MEMORANDUM REPORT ARBRL-MR-03279

BLAST LOADING OF CLOSURES FOR USE
ON SHELTERS

George A. Coulter

June 1983

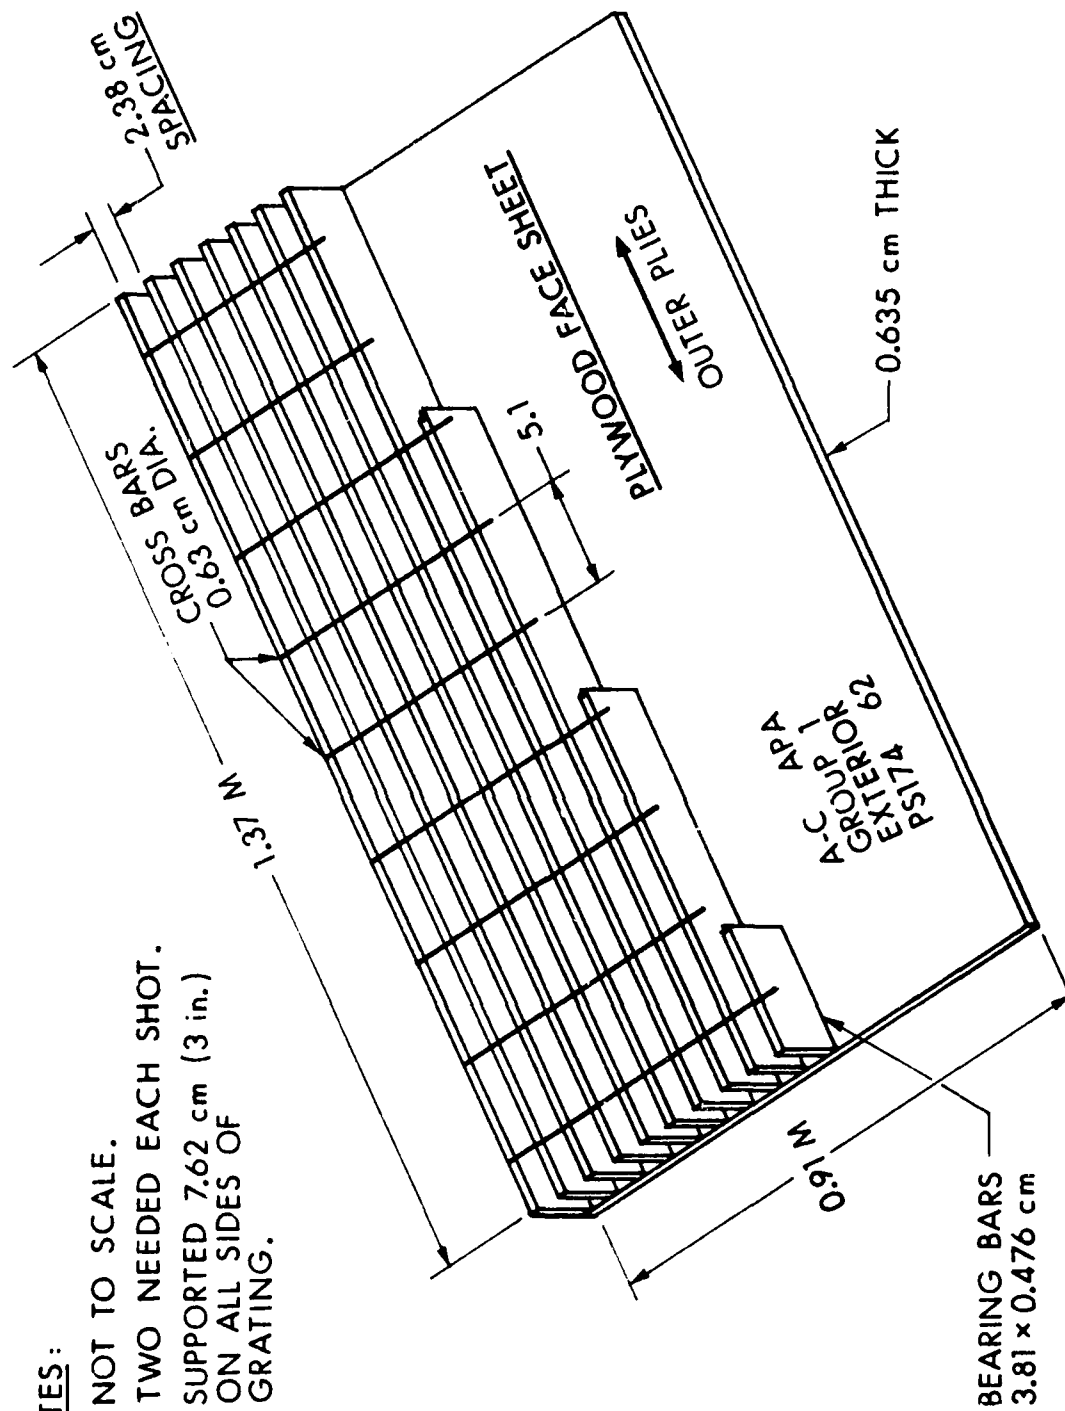
Figure 3. Steel grating/plywood closure.

Figure 3 shows a sketch of ordinary steel grating, covered on one side with plywood (0.635 or 1.27 cm) to contain the blast pressure. The grating normally is sold in a standard width of 0.91 m, so two widths were attached to cover the end flange opening of 1.219 x 1.676 m. Grating was supported 7.12 cm on all sides.

1. NOT TO SCALE.
2. TWO NEEDED EACH SHOT.
3. SUPPORTED 7.62 cm (3 in.) ON ALL SIDES OF GRATING.

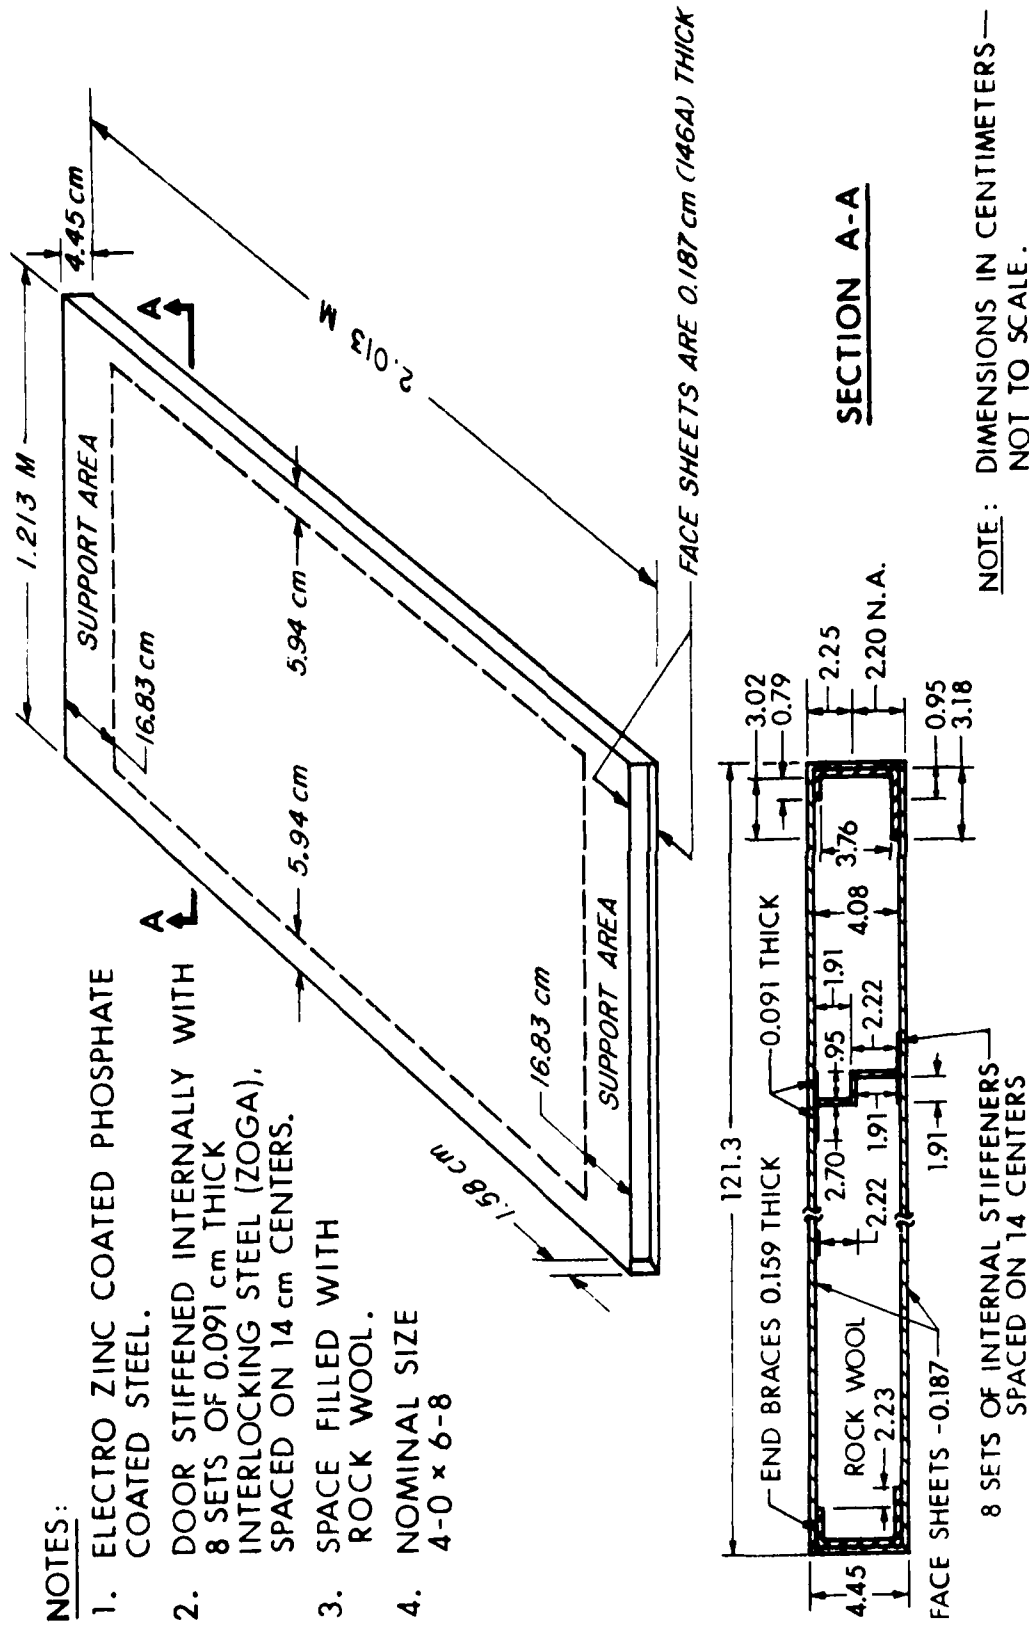
Figure 4. Commercial steel door.

The third closure tested is shown in the sketch, Figure 4. It is the strongest of a set of commercial doors tested before (Reference 3) for FEMA. The doors were full-flush steel, no cutouts, and had internal bracing with a filler of rock wool for insulation. See Figure 4 for supported areas on each edge.

1. ELECTRO ZINC COATED PHOSPHATE COATED STEEL.
2. DOOR STIFFENED INTERNALLY WITH 8 SETS OF 0.091 cm THICK INTERLOCKING STEEL (ZOGA), SPACED ON 14 cm CENTERS.
3. SPACE FILLED WITH ROCK WOOL.
4. NOMINAL SIZE 4-0 x 6-8

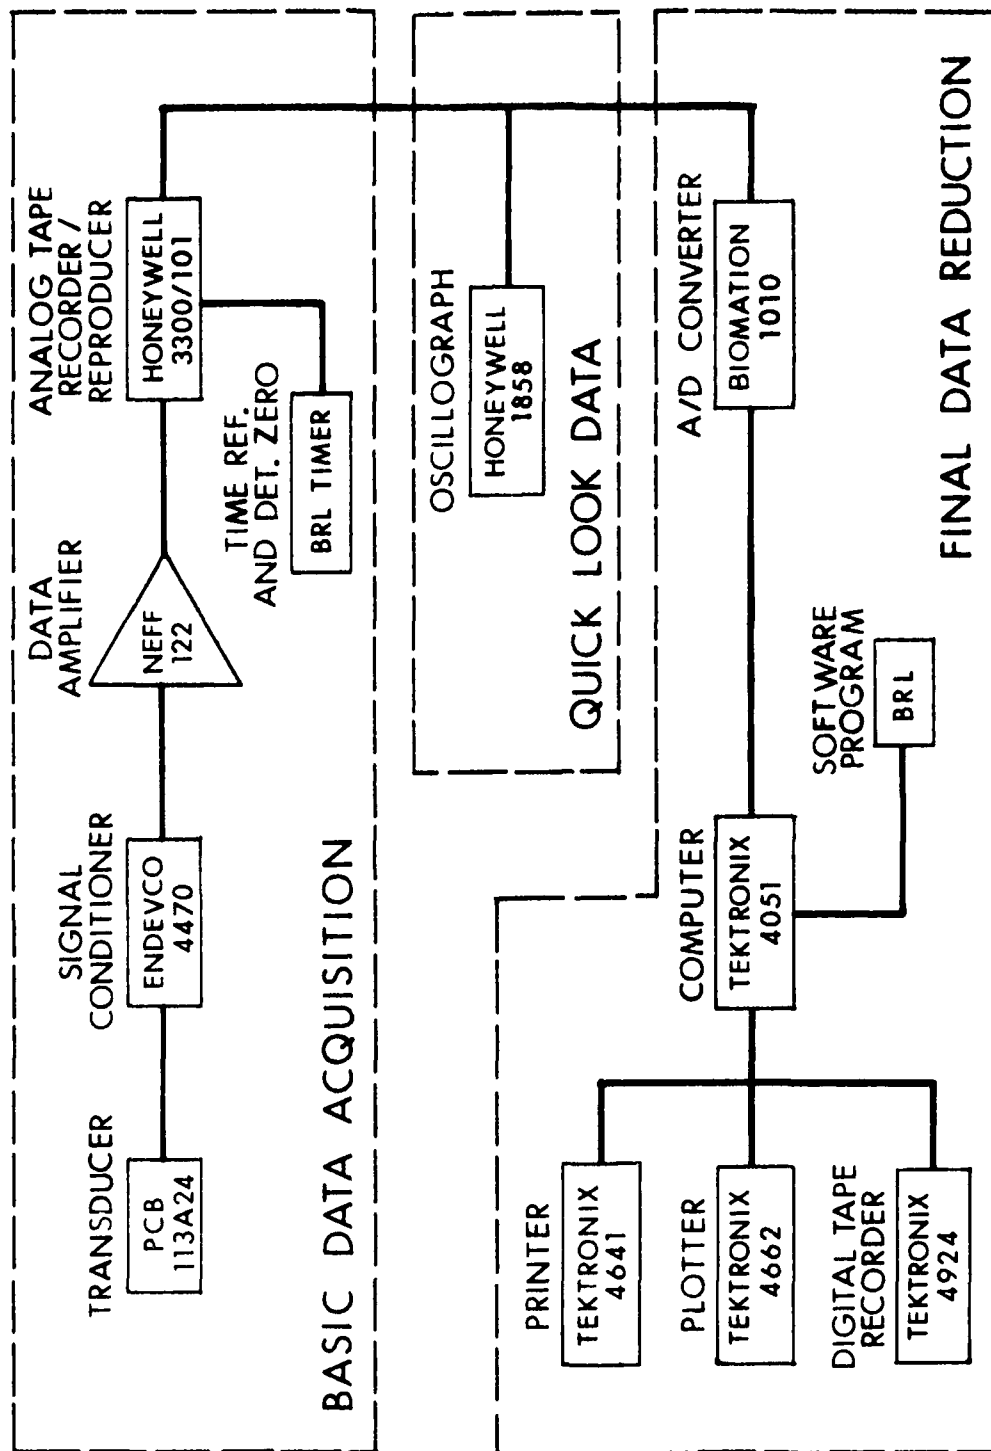
Figure 5. Schematic of data acquisition system.

black, was attached with an aluminum holder to the center of the closure. The black target was tracked against a white background by the displacement follower during the tests. The optical target's image obtained was converted to an electron image in which the electron density was proportional to the corresponding light from the target. The electrical output signal was recorded by the tape machine. The data reduction process was the same as for the pressure data. See Figure 5.

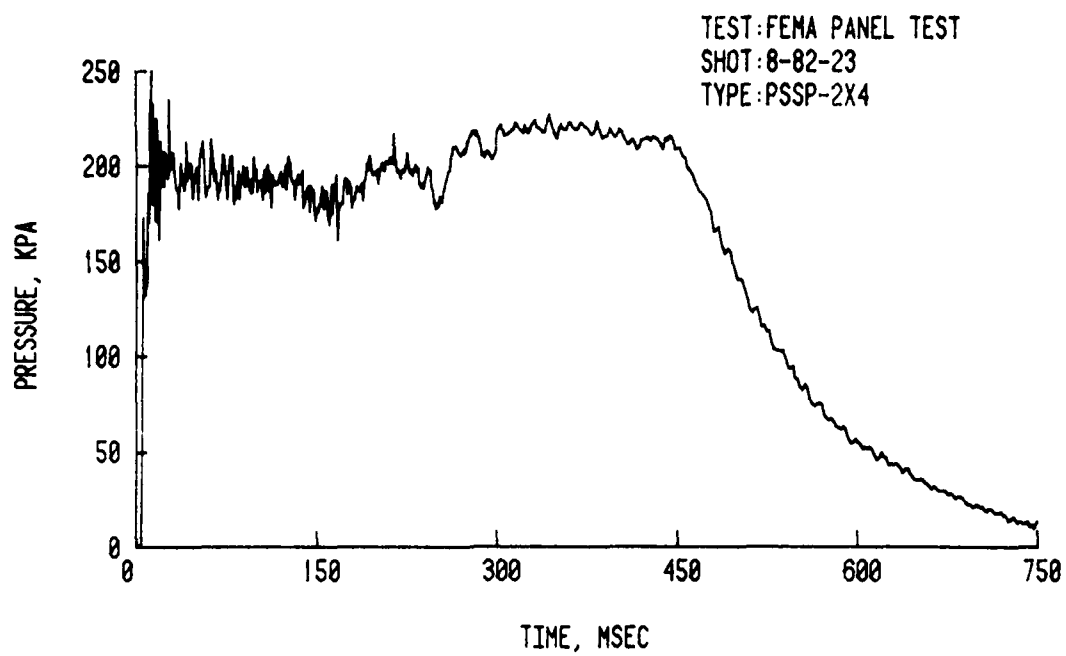
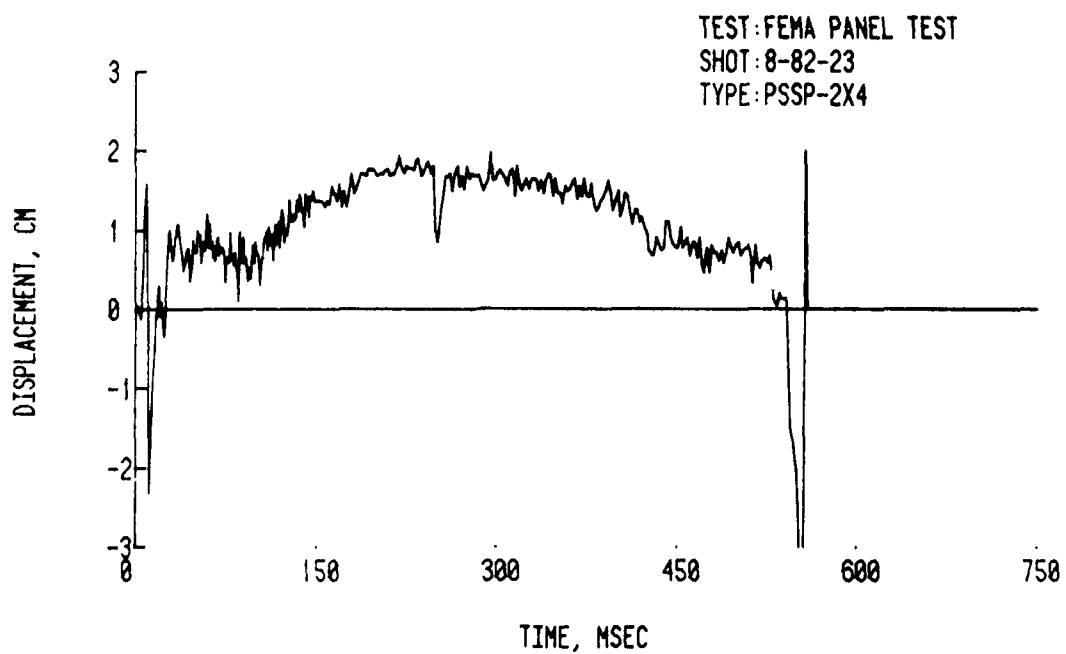
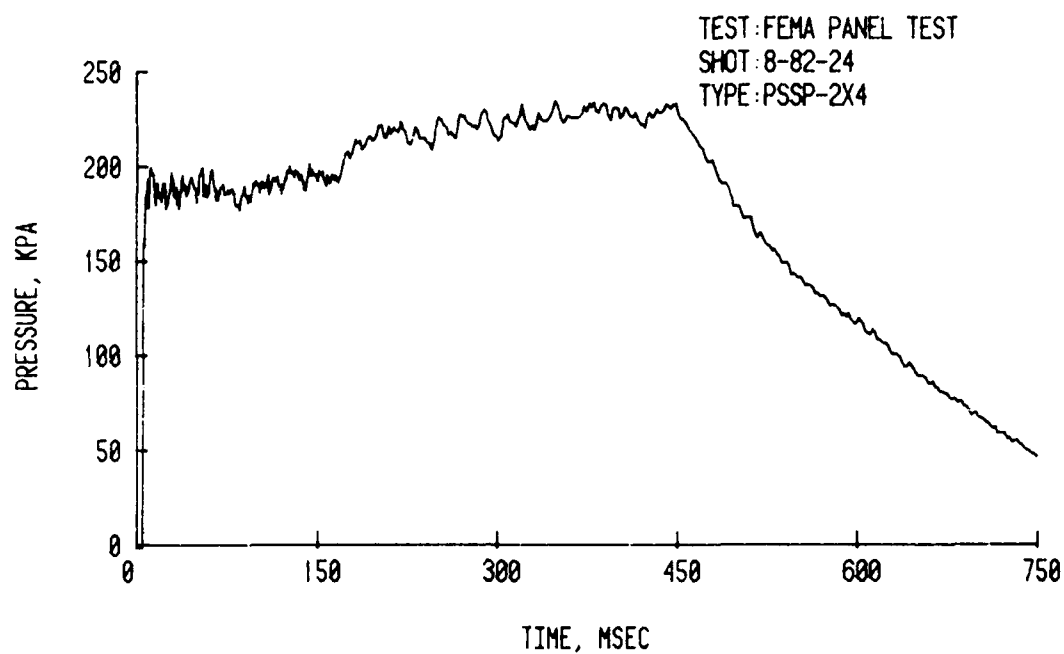
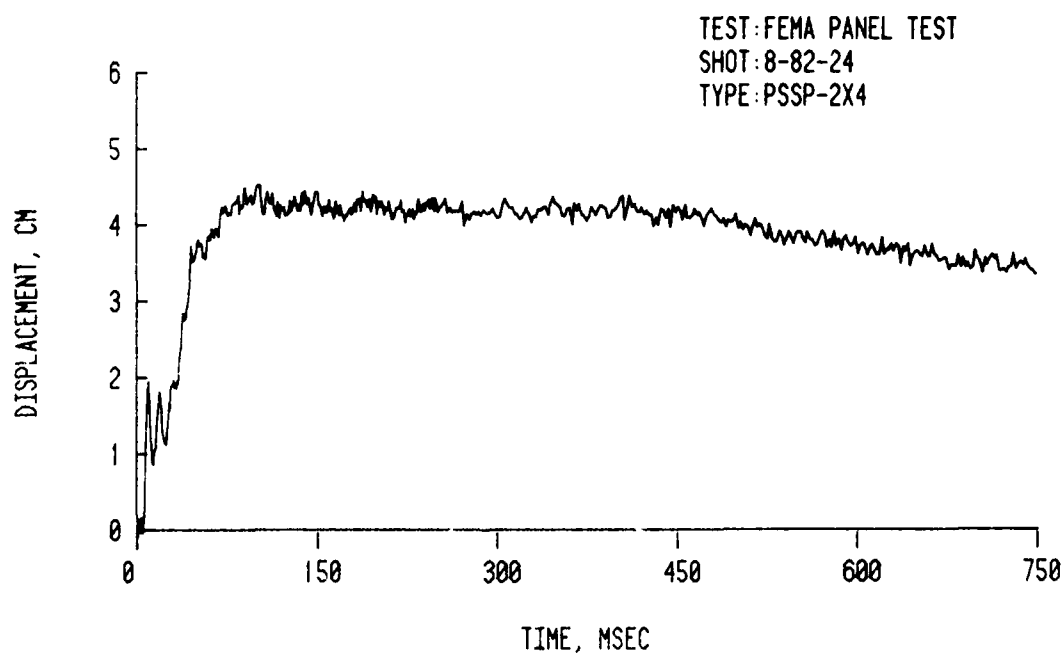
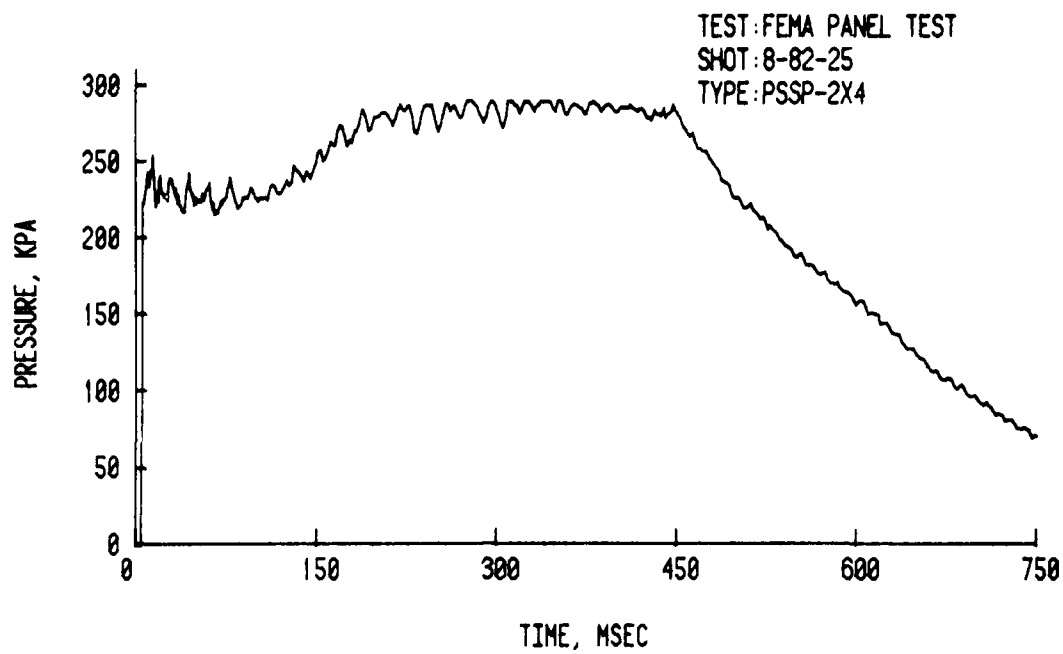
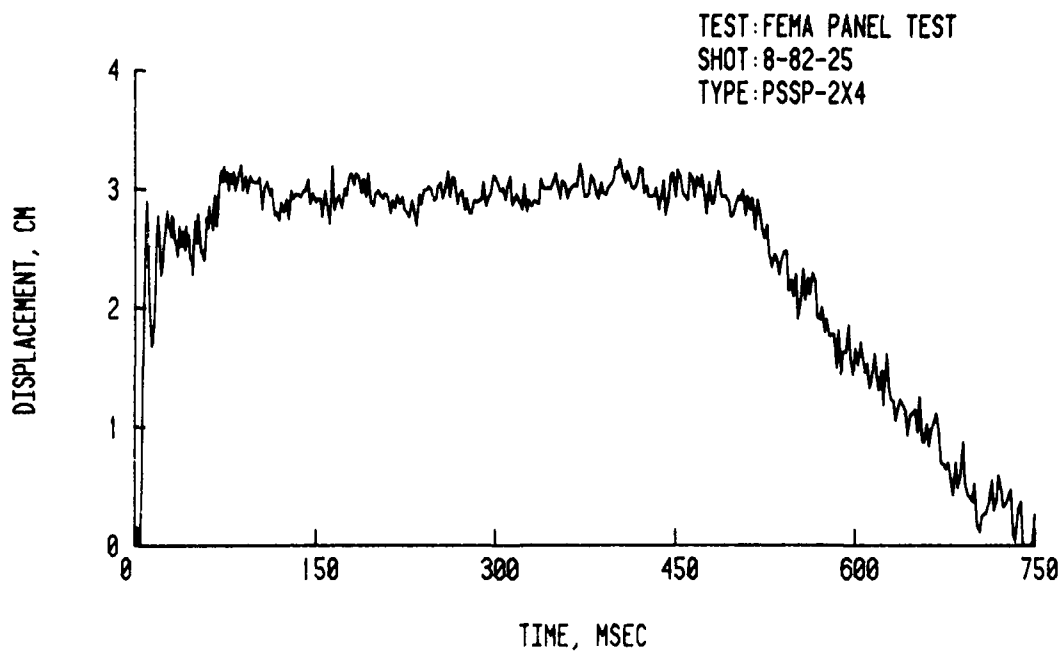
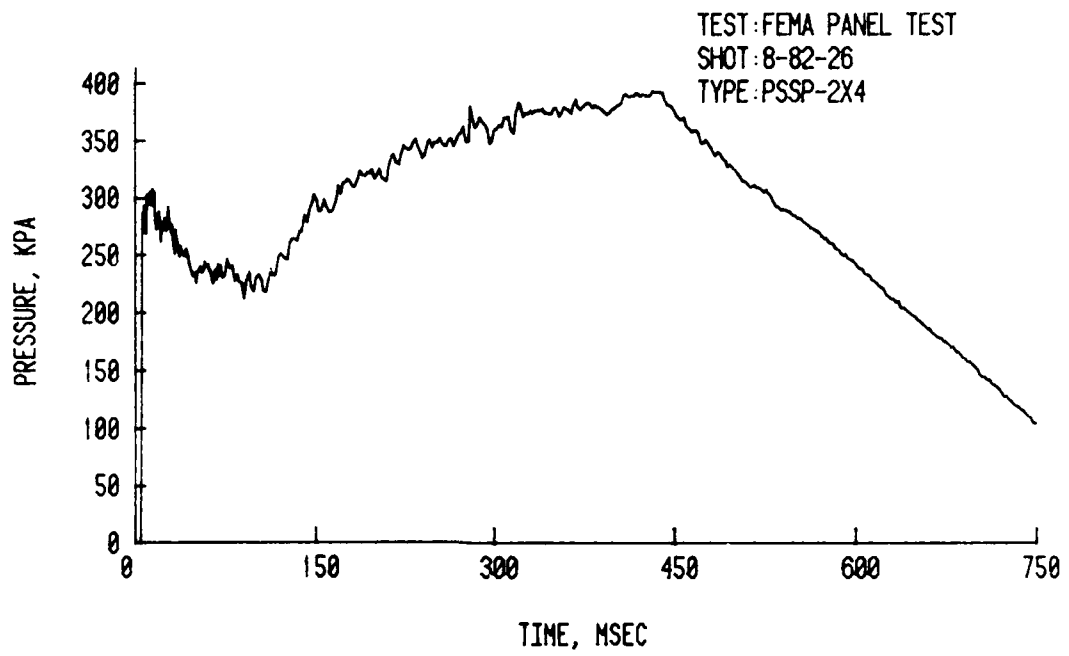
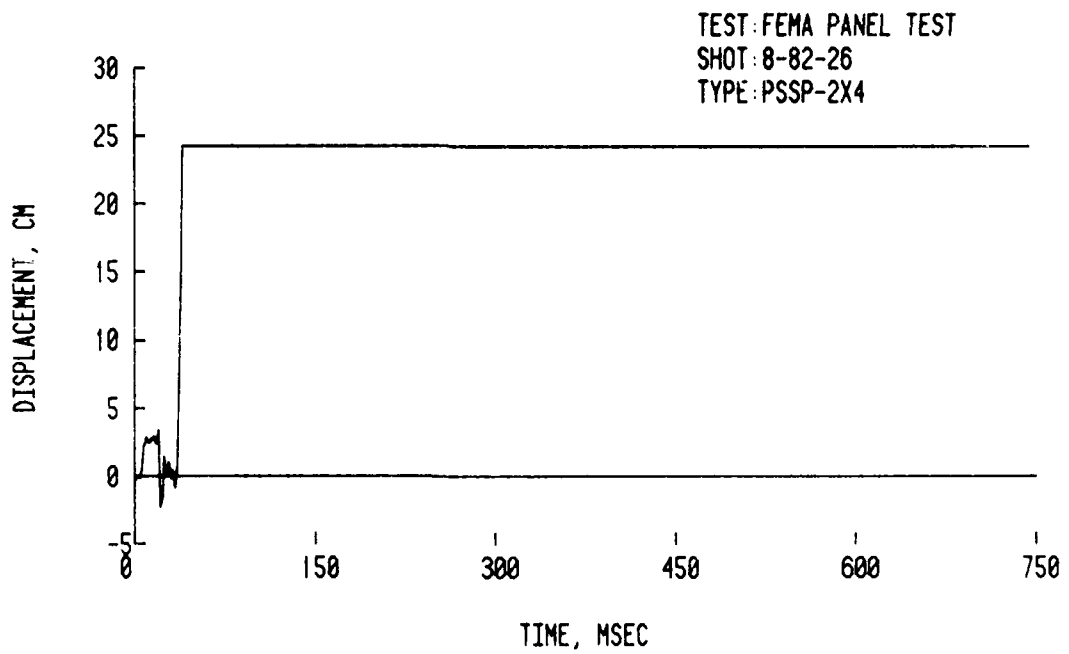
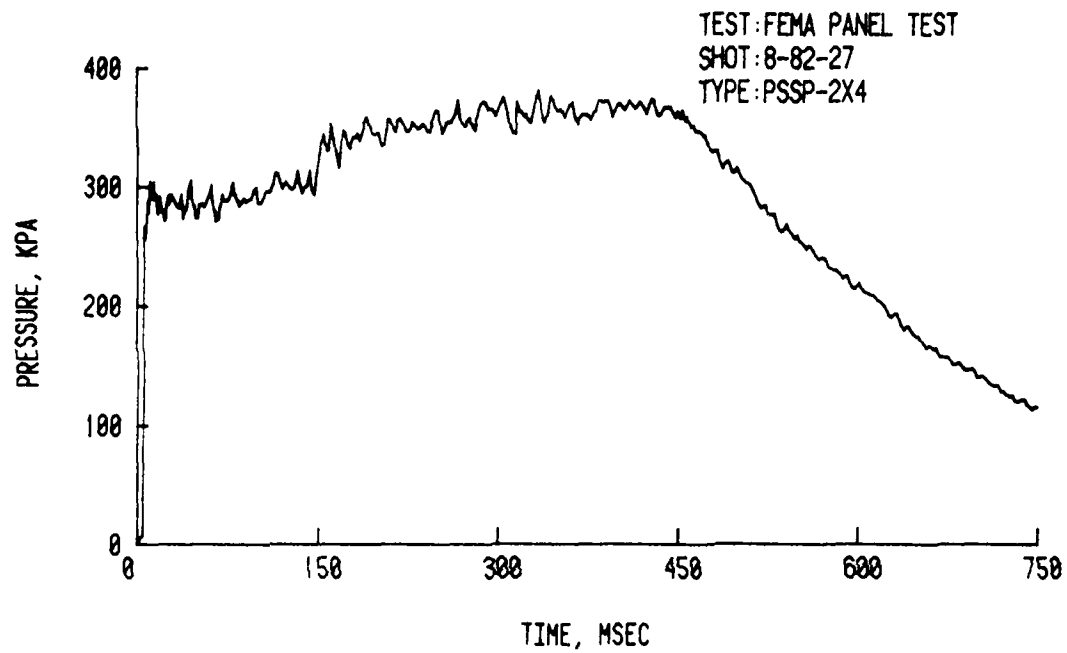
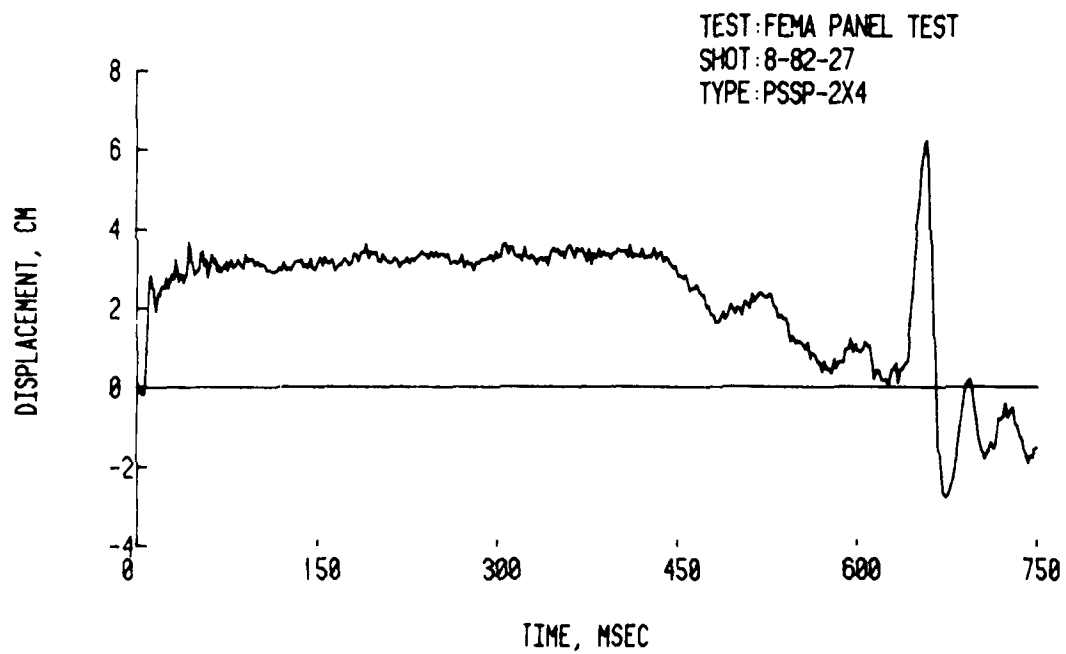
Figure 6. Pressure and displacement records for wood closures.

Figures 6-8 show the pressure and deflection as a function of time during the loading period of the blast wave. The upper pressure record was, of course, modified if the closure opened and allowed blast leakage past the closure. The bottom record (when available) represents the motion of the center of the closure under load as a function of time. When the closure acted correctly, the deflection record follows well the loading pressure. See Shot 8-82-25, 33, and 35 as examples of correct sealing - no venting. The pressure-time record modification by closure failure is illustrated by Shots 8-82-26, 30, and 32. The rarefaction from the release of the pressure load decreases the pressure at the transducer location to a minimum pressure at about 150 ms measured from blast wave arrival at the closure. Shot 8-82-34 shows a rarefaction beginning a little beyond 300 ms indicating closure failure late in the loading cycle. The failure mode is described in Section C below, and closure breakout is best seen on the high-speed photographs of Section D.

The wood beam/plywood closures (Shots 8-82-23 to 8-82-27) were tested through a range of loading pressures from 173 kPa (25.1 psi) to 300 kPa (43.5 psi). Slight damage to the downstream plywood skin by budging occurred at the low end of loading range. At 300 kPa (43.5 psi), the closure was in place and effective although the downstream plywood skin was broken. Two frequencies of vibration were measured for the wood closure: an initial higher one of 102-121 Hz and a lower secondary one of 16-20 Hz. Under higher loads approaching ultimate failure (breakout), these vibrations tend to damp out.

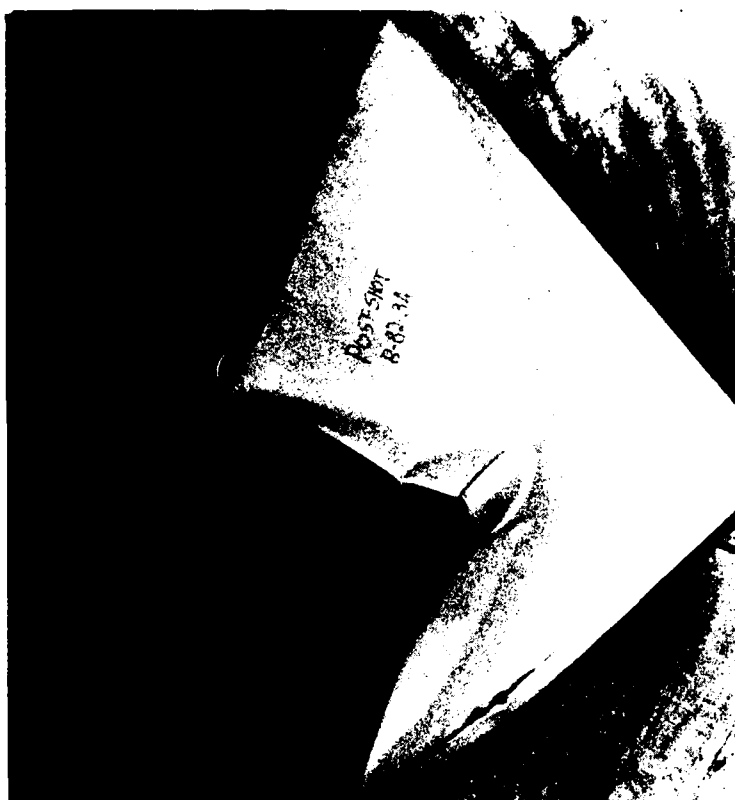
The commercial steel doors began failure by separation of the spot welded downstream face sheet (Figures 17 and 18). Figure 19 illustrates the twisting of the door that occurred at a load of 57 kPa (8.3 psi). At a load of 66 kPa (9.6 psi) the door was thrown out of the holder 40 m from the end of the shock tube. See Figure 20. The failure began at the face sheet seam but final bending occurred at about the center of the door.
